CALSPAN ON-SITE AIR BAG DEPLOYMENT INVESTIGATION

CALSPAN CASE NO. 90-14

FLEET - 1990 DODGE DYNASTY

ACCIDENT DATE - [REDACTED] 1990

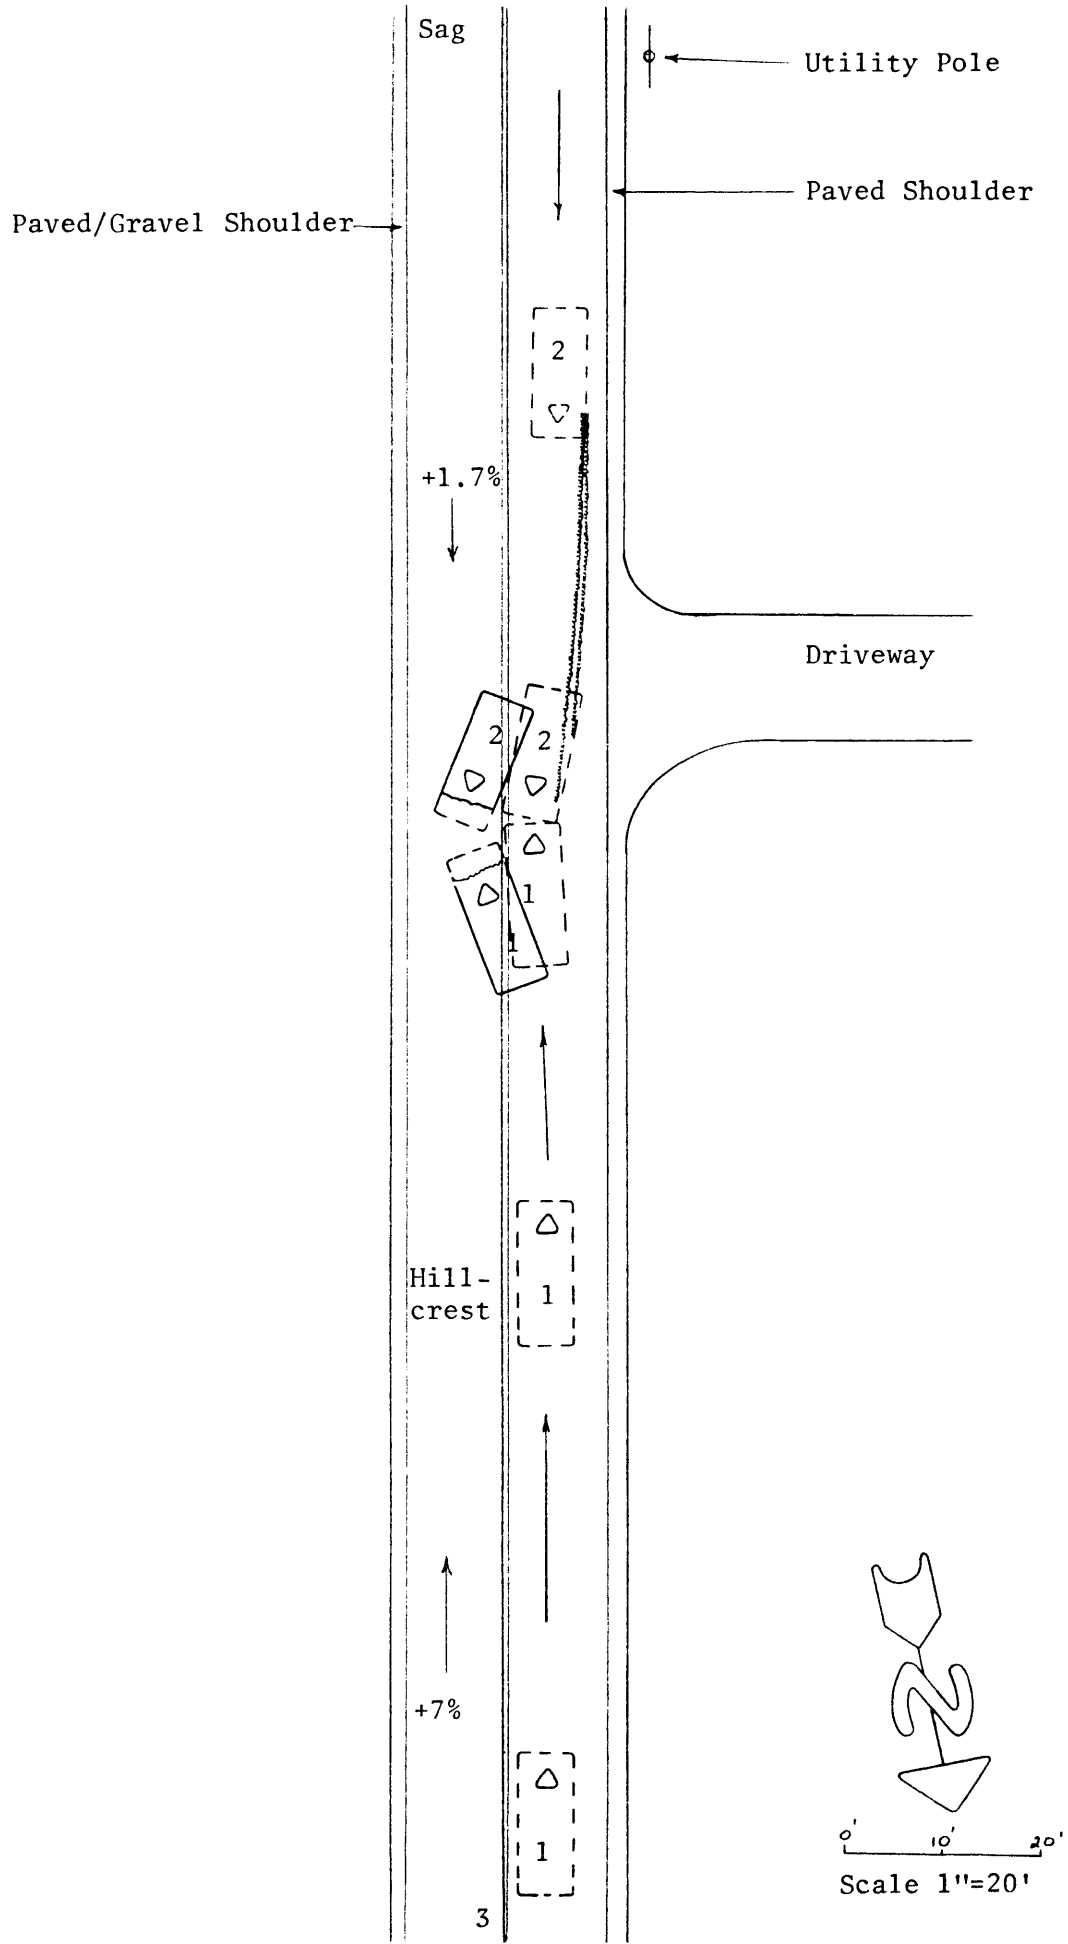
Accident Schematic  
Calspan Case No. 90-14

The driver of the S-10 Blazer noted the Dodge Dynasty as it crested the hill. She applied a clockwise steering input and braked in an attempt to avoid impact. The left side tires of the S-10 Blazer deposited 40'8" of rotating tire scuffs as the vehicle yawed 5° CW along its trajectory to impact.

Crash: The vehicles impacted in a head-on configuration in the south-bound travel lane approximately 50' south of the hillcrest. Impact speeds were computed at 36.8 mph for the air bag vehicle and 45.2 mph for vehicle #2 by the damage and trajectory mode of the CRASHPC program. Both vehicles sustained impact forces that were within the 12 o'clock sector with velocity changes of 41.7 mph for the air bag vehicle and 40.7 mph for the S-10 Blazer. As a result of the crash, the Dynasty's driver air bag system deployed.

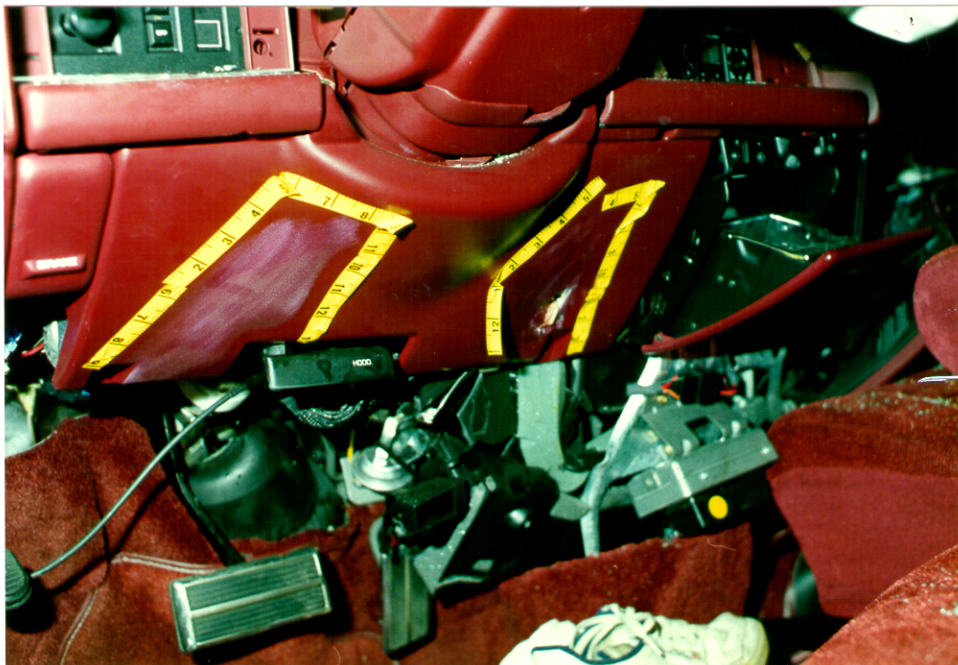
The air bag in the Dodge Dynasty was tethered and measured approximately 23" in diameter. The maximum depth of the bag was 8-9". The bag was vented by two venting ports located at the 3 and 9 o'clock positions. There was no generant residue in the area of the venting ports. The air bag was intact with no damage to the bag material.

Overall View Of The Deployed Air Bag And Driver Knee Contacts

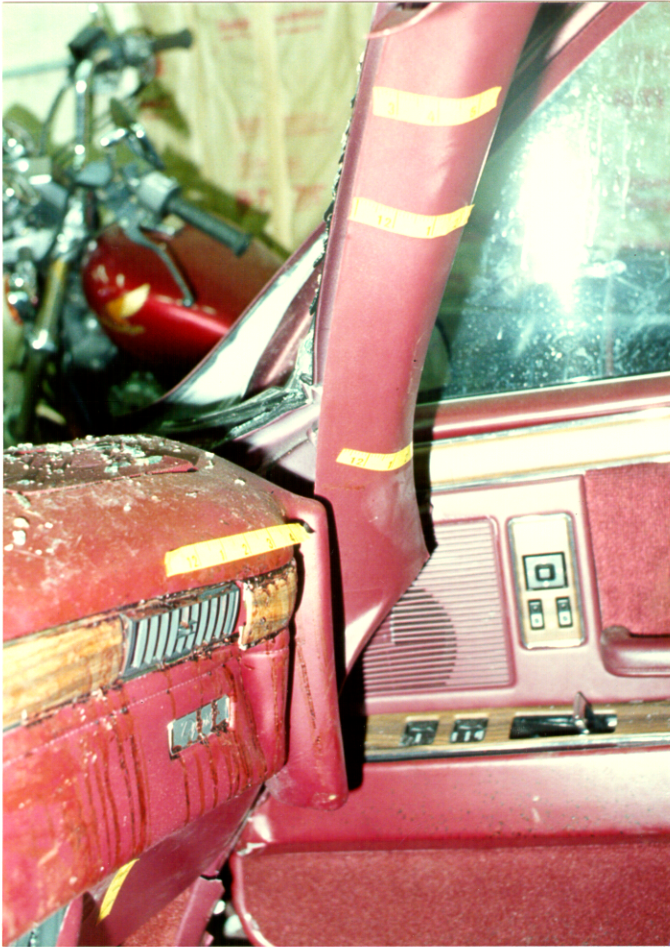
Interior of center and involved a 6.5" diameter area of depression  
(Air Bag with a maximum depth of .75". The passenger's head and  
Vehicle) face struck the right A-pillar (scuff mark) and windshield.  
(Cont'd.): Hair and tissue deposits were noted to the windshield  
2.5 - 4" inboard of the pillar and 5 - 17" below the windshield  
header. There was also a U-shaped tear of the plastic laminate  
at the lower portion of the tissue deposit.

Right Front Passenger Contact Points

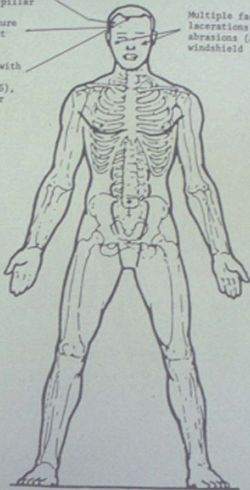
Multiple facial  
lacerations and  
abrasions (AIS-1),  
windshield

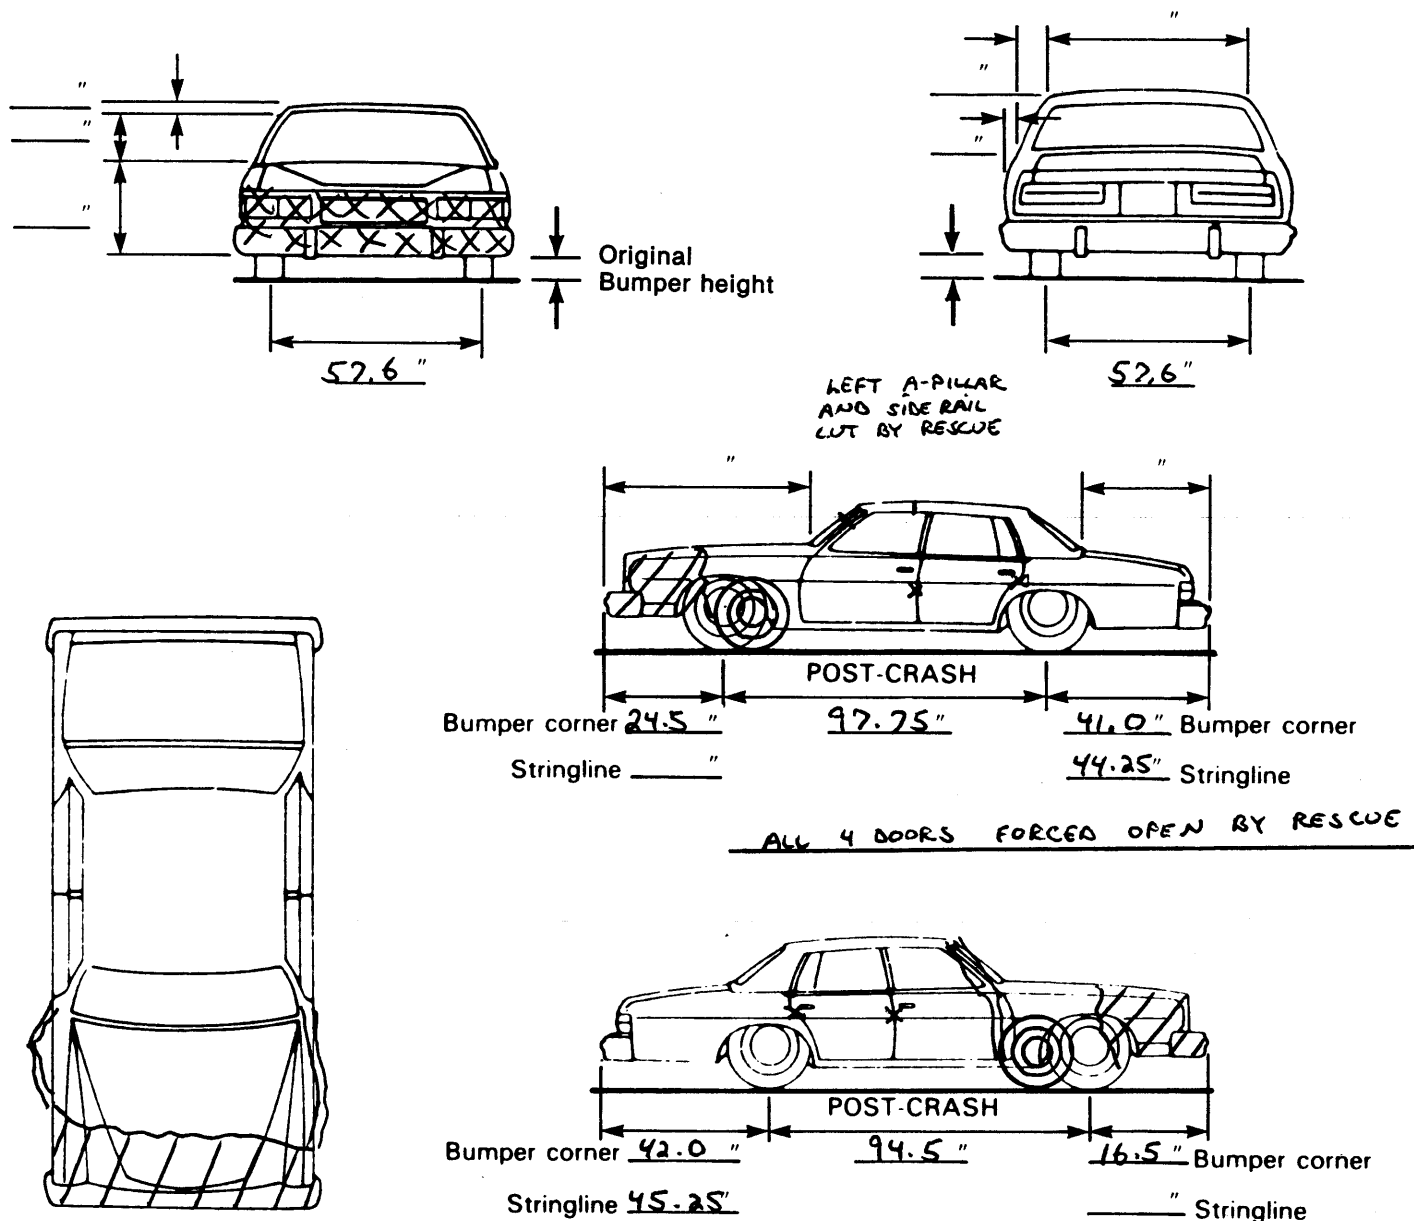
## VEHICLE DAMAGE SKETCH

Specific Impact No.	Location of Direct Damage	Location of Field L	Location of Maximum Crush
1	FRONT BUMPER 53.5"	FRONT BUMPER 53.5"	ON BUMPER, 13.5" RIGHT OF CENTER

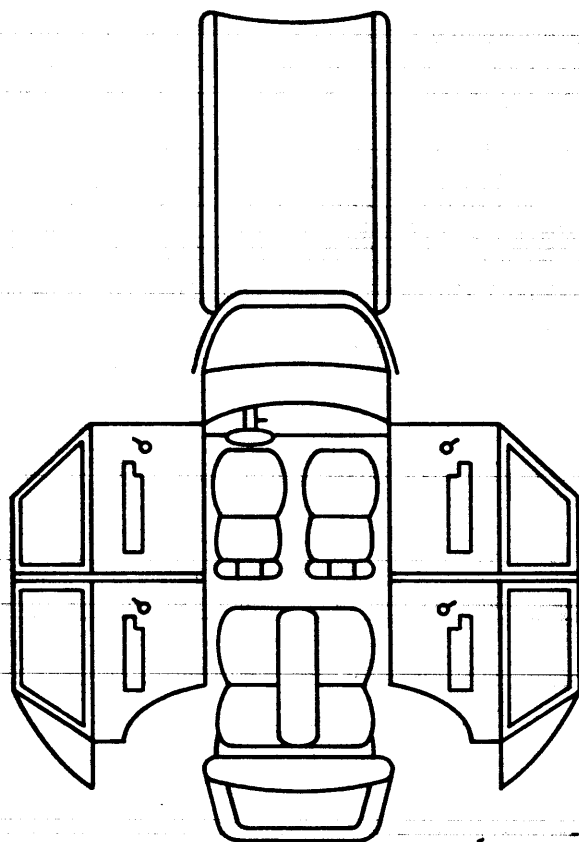
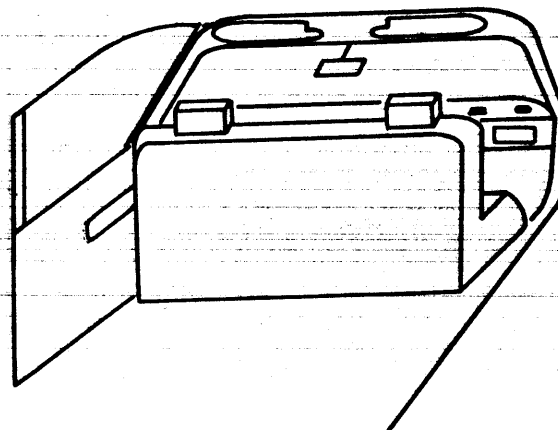
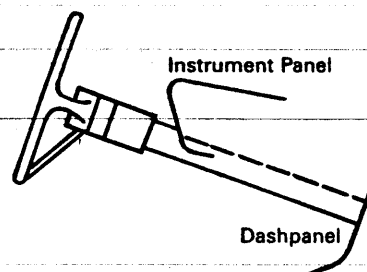
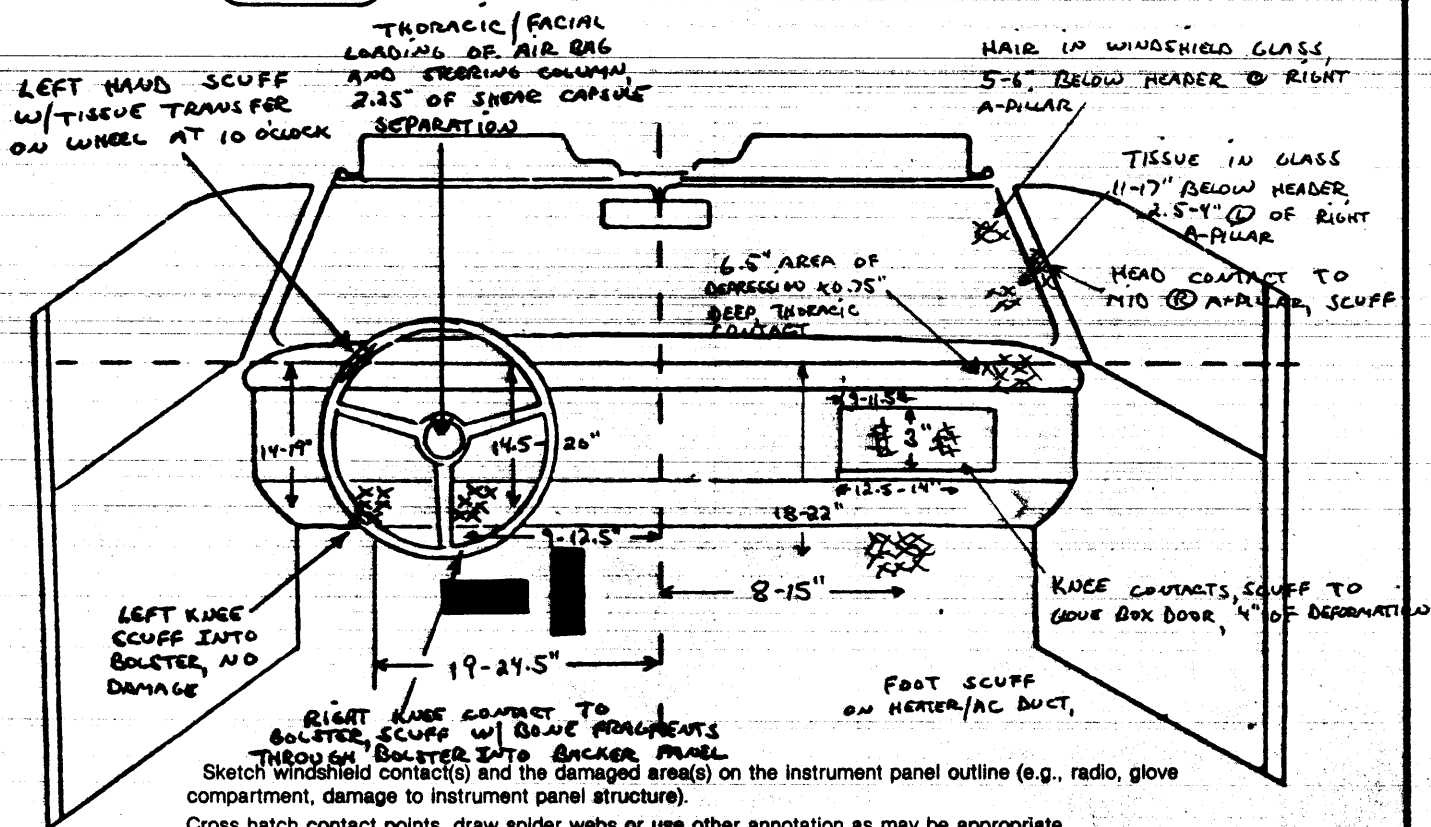
## VEHICLE INTERIOR SKETCHES

Contact	Interior Component Contacted	Occupant No. If Known	Body Region If Known	Supporting Physical Evidence	Confidence Level of Contact Point
A	45	1	FACE/TORSO	TRAJECTORY	1
B	13	1	① KNEE	SCUFF	1
C	13	1	① KNEE	BONE FRAGMENTS	1
D	04	1	TORSO	2.5" SHEAR COMPRESSION	1
E	04	1	① HAND	SCUFF/TISSUE TRANSFER	1
F	12	2	KNEES	SCUFFED, DEFORMED	1
G	11	2	TORSO	1.75" x 6.5" DEPRESSION	1
H	32	2	HEAD	SCUFF	1
I	01	2	FACE	HAIR/TISSUE	1
J					
K					
L					
M					
N

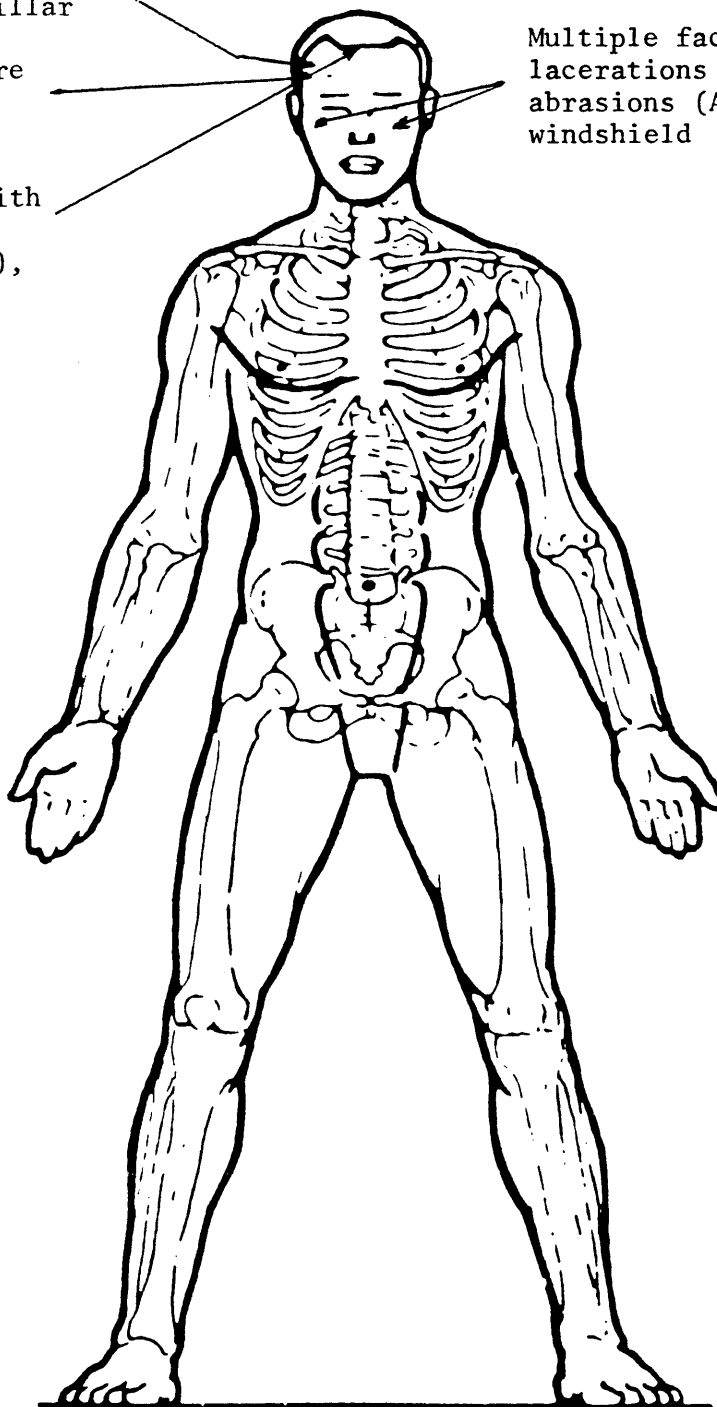
Multiple facial  
lacerations and  
abrasions (AIS-1),  
windshield

**AGE** 16  
**SEX** Female  
**WT.** 100 lbs.  
**HT.** 64"
